# Life cycle assessment of refurbishment scenarios to confined tank structures at a waste water treatment plant

**ABSTRACT:** The paper will show a Life Cycle Assessment (LCA) of three different refurbishment scenarios for confined tank structures at a waste water treatment plant. – One using a traditional Portland cement based repair mortar, one combining this cement repair mortar with a reactive protective coating, and one using 100% calcium aluminate based repair mortar technology. In order to evaluate the sustainability and potential environmental impact of each of the three scenarios, the Life Cycle Assessments (LCA) were performed, which included Cumulative Energy Demand (CED), Global Warming Potential (GWP) and Photochemical Ozone Creation Potential (POCP). The results are compared and analyzed in this paper, particularly in relation to extending the structural service life, which shows how innovative systems can give advantages to designers and contractors, which in turn are also of benefit to their customers.

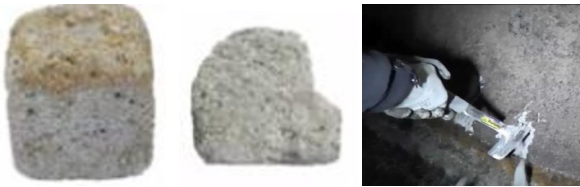
**Fig. 6 & 7:** OPC mortar containing fly ash, silica fume and silica sand after 1 year in an incubation chamber simulating the biogenic corrosion – the picture on the left being the cube at the start of the test and the one in the middle at 1 year later (3).

**Fig. 8:** The picture on the right is in a large waste collector near Paris, where a repair mortar is being scratched off easily, due to its deterioration by biogenic corrosion, just a few years after the installation.

Scenario-1 entails higher environmental impact in the three categories compared to the others. This is due to the necessary repetition of the retrofitting, as all types of Ordinary Portland Cement based system are very sensitive to acid attack generated by biogenic activities.

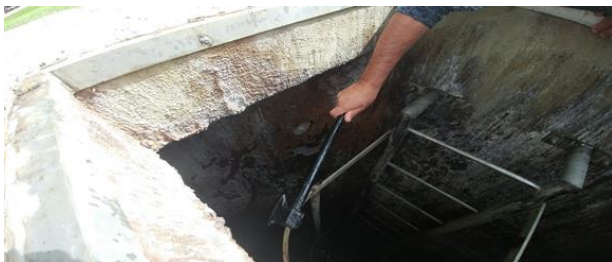
**Fig. 9:** Picture taken in Israel where a system similar to Scenario-2 has shown premature failure after just 5 years in service.
